CHELONIAN CONSERVATION AND BIOLOGY

Restoration of Wetland and Upland Habitat for the Blanding's Turtle, Emydoidea blandingii

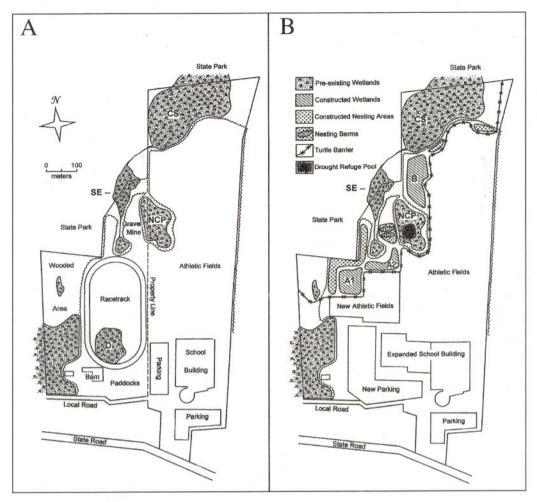
Figure 1. Maps of 1996 pre-restoration (**A**) and 1997 post-restoration (**B**) features. A1, A2, B = constructed wetlands; CS = Corner Swamp, NCP = North Campus Pond, SE = Southeast Swamp; D = donor wetland. (Drawn by Kathleen A. Schmidt).

The restoration site lies between a public school and a state park on land that was farmed until around 1950 (Fig. 1). There are approximately 6 ha of pre-existing wetlands suitable for Blanding's turtle use, and 1.4 ha of constructed wetlands built in 1996–97. A "donor" wetland (0.7 ha) provided much of the soils and vegetation for the constructed wetlands. All the wetlands are underlain by organic sedi-

A 1.5 km long fence was built along two sides of the restoration area (Fig. 1B) to reduce turtle movement from the restoration area towards the parking lots and highway, and to discourage human entry into the restoration area. The fence was composed of 1.2 m high chain link with 0.6 m high aluminum sheeting attached to the bottom on the restoration side and buried 0.3 m in the soil. The fence had one-way turtle gates at 30 m intervals, with earth ramps on the school

Two females and 1 male used the constructed wetlands in summer and fall 1997 (Fig. 5). Many of these radiolocations were in wetland A1 (Fig. 1B) which held standing water throughout the drought. One female used the newly dredged pool in North Campus Pond during the drought. In winter 1997–98, 6 radiotracked adults overwintered in Corner Swamp and Southeast Swamp (Fig. 1B). Other adults overwintered in a small water-supply pond in the park north of the restoration area where they had spent much of the 1997 drought (these turtles moved into a small intermittent woodland pool during unusually warm weather in February 1998, then back to Corner Swamp and Southeast Swamp). No Blanding's turtle used the constructed wetlands in 1998 until the nesting season began on 25 May.

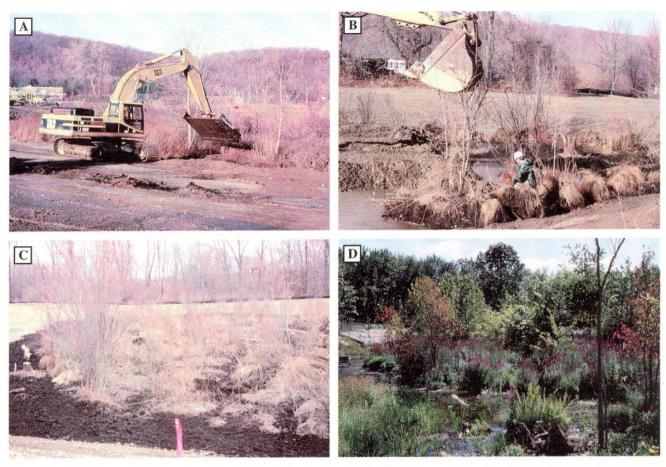
Figure 3. Blanding's turtle habitat restoration, Dutchess County, New York. (A) Sod removal from the donor wetland, December 1996; (B) and (C) Sod placement in constructed wetlands, November and December 1996; (D) Completed constructed wetland, September 1997. (Photos by EK, Hudsonia, Ltd.)

Implementation. — To create an immediately functional habitat, we used the "whole sod" salvage method developed by Munro (1994). We salvaged organic sediments and vegetation from the donor wetland including mature sedge (*C. stricta*) tussocks, woody hummocks (elevated root crowns), mature shrubs, and trees up to 12 cm dbh (diameter at breast height, measured 1.4 m from base) and 6 m tall, before the wetland was filled for school construction. Using a custom-made steel spatula mounted on an excavator, whole sods of 1.2 x 3 m, including all vegetation and a 38 cm deep layer of organic sediments, were cut from the donor wetland and transferred to newly excavated basins 200–700 m away (Fig. 3). All underlying organic material was also salvaged and used to fill gaps between sods and line pools with 20–40 cm of organic

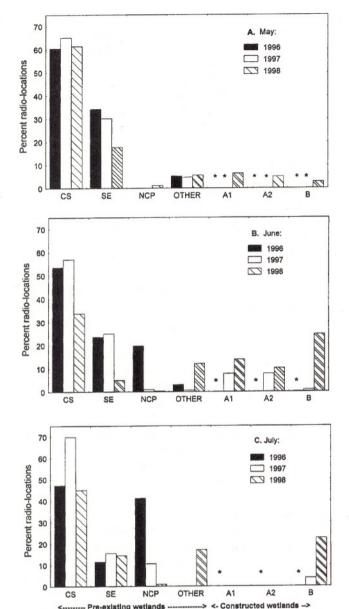
Figure 5. Radio-locations of adult Blanding's turtles in preexisting wetlands and constructed wetlands 1996–98. Numbers on the y-axis are percentages of total radio-locations for a month-yearwetland combination. CS = Corner Swamp, SE = Southeast Swamp, NCP = North Campus Pond. * indicates wetland did not exist or was not accessible to turtles.

In 1996 (before wetland construction), adult Blanding's turtles concentrated their activities in Corner Swamp and Southeast Swamp (Figs. 1, 5). We located two Blanding's nests on the edges of the racetrack. A third nest of either Blanding's turtle or wood turtle (*Clemmys insculpta*) discovered at the end of the summer had been dug in a compost pile near the racetrack and apparently produced no live hatchlings. Five additional radiotracked females did not develop palpable, shelled eggs, probably due to the very cold, late spring.

season. Five females and 2 males used the constructed wetlands after the nesting season (July, Fig. 5), with 2–7 radiotracked adults in the constructed wetlands on any one date.
